The Remediation of the Hollinger Tailings Stack – A Case Study in Government Response to a Problem

Abstract

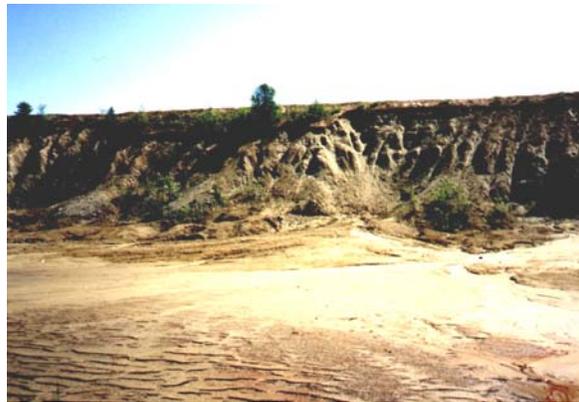
The slopes of the stack were showing severe erosional scars in a number of areas. As well, the high phreatic line, constantly recharged by the large ponds on top of the stack, was causing the toe of the slope to erode, undercutting the slope and causing the surface to slump further and

migrate towards the crest of the stack (see Figure 1).

Figure 1 – Severe slope erosion and sloughage

- 1) Drain the ponded water using a permanent spillway on the east side and a set of internal ditches
- 2) Construct a rockfill toe berm and drainage network to shore up the eroded slopes
- 3) Re-slope the west and south-west sections to a more stable configuration
- 4) Re-vegetate the stack to reduce erosion, stabilize the tailings and provide wildlife habitat

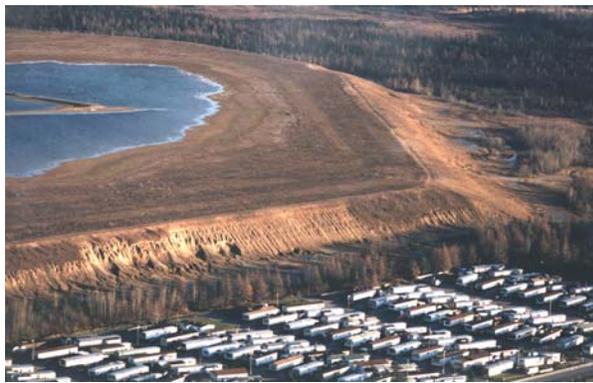
At risk from such an event was a residential trailer park, shown on Figure 2, located immediately at the toe of the 20 to 25 metres tall stack. There were no doubts that a failure towards the trailer park would have disastrous consequences. This realization forced the Province to assess further the situation with a view of solving this problem as quickly as possible.

Figure 2 – Aerial view of stack and trailer park

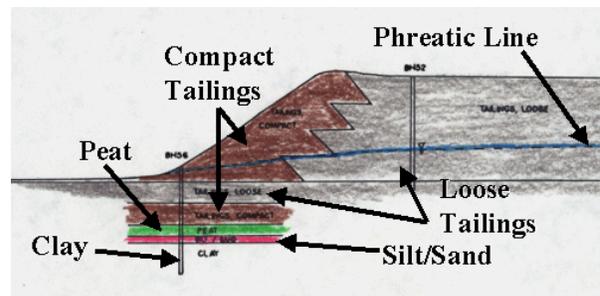
The Crown carried out some preliminary field work during the winter of 1991-92. The stack was surveyed and a geotechnical investigation was performed to determine the properties of the tailings and the site conditions. The field work indicated that the tailings were loose to very loose in density, saturated to near-surface and with average SPT (Standard Penetration Test) blowcount values of 5 below the phreatic line and 8 above. The site stratigraphy, shown in Figure 3, is as follows, tailings overlying a thin seam of sand, peat, and inorganic clays of low plasticity to non-plastic silts. The hydraulic conductivity was estimated at 1×10^{-5} to 1×10^{-6} cm/sec, corresponding to fine sands and silts. The friction angle of the tailings was estimated at 35 to 40 degrees.

Figure 3- Soils/tailings stratigraphy at the site

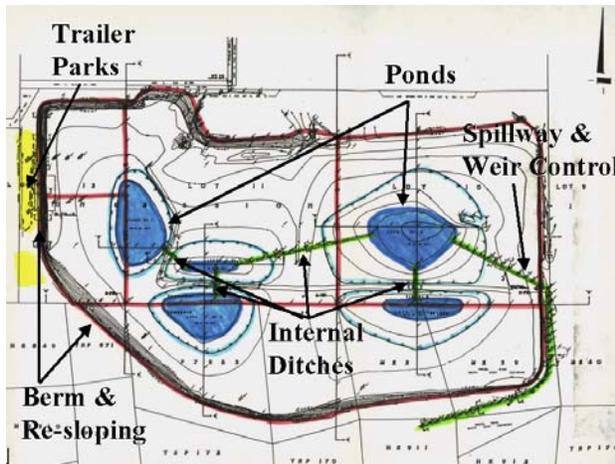
Figure 4 – Proposed rehabilitation measures for the site

The Crown decided to implement the following measures (see Figure 4):

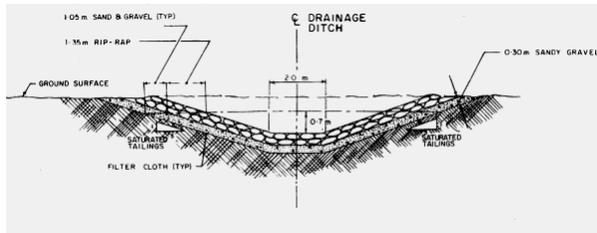
Figure 5 – Spillway cross-section

The spillway design required rip rap armouring to a water depth of 3 metres to prevent scour. The remainder of the spillway was vegetated. The spillway would be lined with a geotextile to separate the tailings from the 0.35m thick sand and gravel filter which in turn would be covered with a 0.45m thick rip rap layer (see Figure 5).

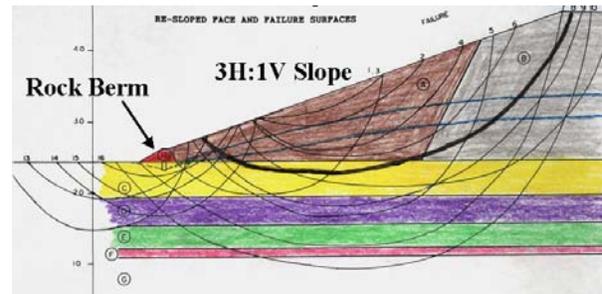
The selected slope was modeled for slope stability. The static FOS increased from 1.1 to 2.0. The pseudo-static FOS for the 1000-year seismic event increased from 0.9 to 1.6 assuming no liquefaction. Under a worse case scenario, assuming that the tailings would partially liquefy coupled with an elevated phreatic line, the pseudo-static FOS was reduced to 0.98, which is marginally stable (see Figure 6). Overall, it was believed that the rock berm and re-sloping design would provide a reasonable cost-effective solution to the problem.

Figure 6 – Re-sloped cross-section

The rock berm contained a 2.5m wide crest width for constructability and side slopes of 1H:1. The height of the berm ranged from 1.5m at the south-west end to almost 5m at the corner where the west slope joins the south-west slope. As part of the design, a thick non-woven geotextile was specified between the berm and the tailings. Re-sloping was done on both the west and south-west slopes. Due to the proximity of the trailer park to the west slope, re-sloping was limited to 3H:1V. On the south-west slope where space limitation was not a factor, the slope was further reduced to 3.75H:1V. It should be noted that a 3H:1V slope is generally accepted as the steepest slope practicable that will easily maintain a vegetation cover and minimize erosion.

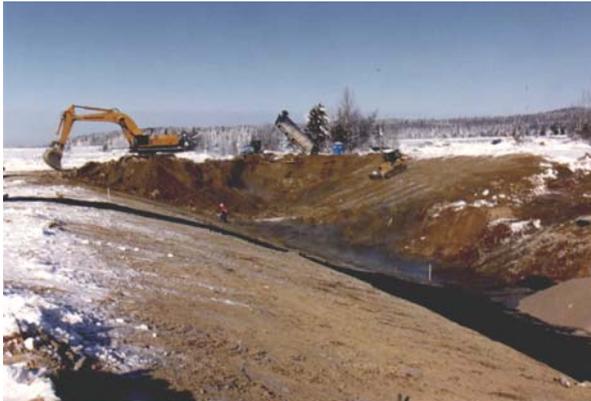
Figure 7 – Main spillway construction

It should be noted that construction work on tailings is generally only feasible during winter when the cold temperatures freeze the ground sufficiently to permit large equipment to work on it, particularly in the area where the ponds were located. There were several instances where the contractor had to stop work for a few days to let the ground freeze. Figure 7 shows the construction of the main spillway.

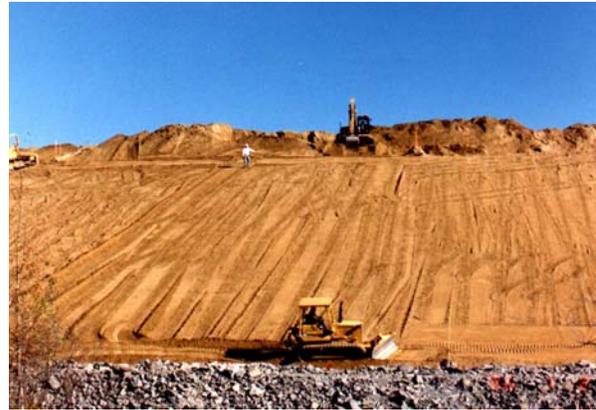
Figure 8 – Re-sloping work

The last phase of the work was done during the fall of 1994. The contractor mobilized a large equipment fleet for the re-sloping work. Several bulldozers, excavators and trucks were used to cut, push, excavate and haul tailings from the stack to reduce the slope on the west and south-west sides (see Figure 8). A geotextile was placed against the upstream slope of the rock berm and the tailings were pushed against it. Compaction of the tails was done using the bulldozing equipment and verified by independent testing. Several rock-lined trenches were built to allow the rock berm to drain into the nearby drainage system to remove water from the toe of the stack and ensure long-term stability.

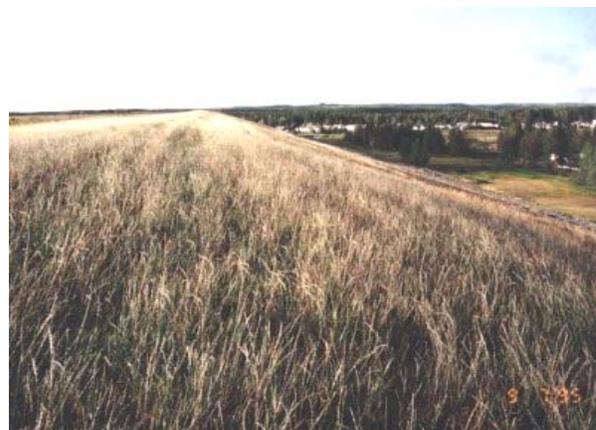
Figure 9 – Revegetated west slope

Follow-up inspections have shown that the rehabilitation work done on the stack was successful. The volume of ponded water has been reduced considerably and the west and south-west

sides of the stack appear to have a sustainable vegetative cover. Recent inspections have since shown the south side, where no remedial work was carried out, is now in need of repair, having deteriorated somewhat from the 93/94 era.

Figures 9 and 10 show the completed work. Total cost was \$1.76M spent over three years including \$120,000 for field work, engineering and site supervision services.

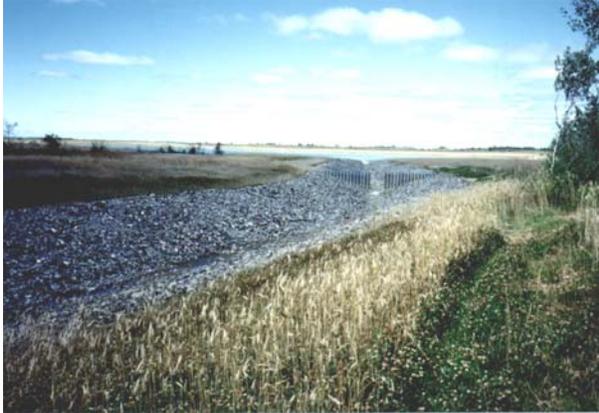
Figure 10: Completed main spillway
