Ten years experience of a multi-layer cover system for uranium mill tailings in Ranstad Sweden

Björn Sundblad
SWECO VIAK, Hospitalsgatan 22, S-611 32 Nyköping Sweden

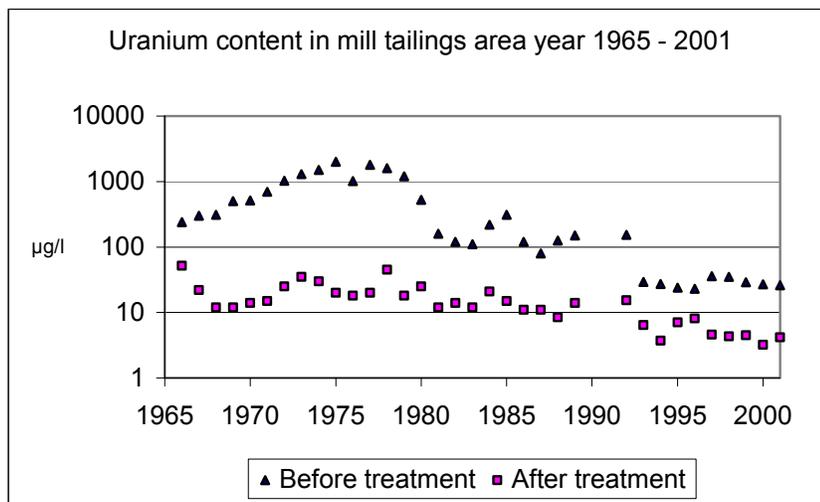
The mill tailings were leaching considerable amounts of pollutants as e.g. uranium. It is obvious from figure 2 that very high concentrations were observed in the mid 1970's. Different studies were performed during the 1970's and 1980's to find effective

The reduction of the metal concentrations in the leakage water after remediation is presented in figure 4. Most of the metals are reduced with a factor about 4 to 5 except arsenic. The reduction, if the former remediation in the 1970's is included, as high as a factor of about 100 for uranium, see figure 2. The uranium concentration indicate that the reduction has occurred in two steps. The first step took place in the end of 1970's and the next one in the 1990's after the primary respectively final remediation.

Figure 2 The uranium concentrations in leakage water before respectively after treatment year 1965 to 2001

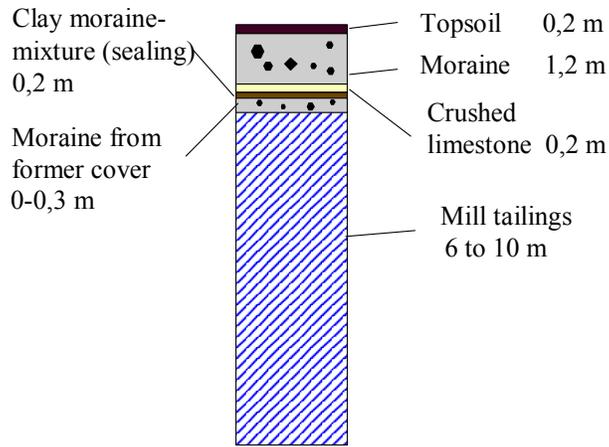
was the most complicated part of the restoration, considering the County administration's requirement of a hydraulic conductivity less than $5 \cdot 10^{-9}$ m/s. Also such factors as availability of material, the long-term stability and the experience from using the material had to be considered in the design of the covering system. The preferred solution is shown in Figure 3. A layer of crushed limestone above the sealing layer works as a drainage layer. Furthermore a protective layer of moraine with a thickness of about 1,5 meter was placed on top of the other layers.

Figure 3 The cover system of the mill tailings depository in Ranstad

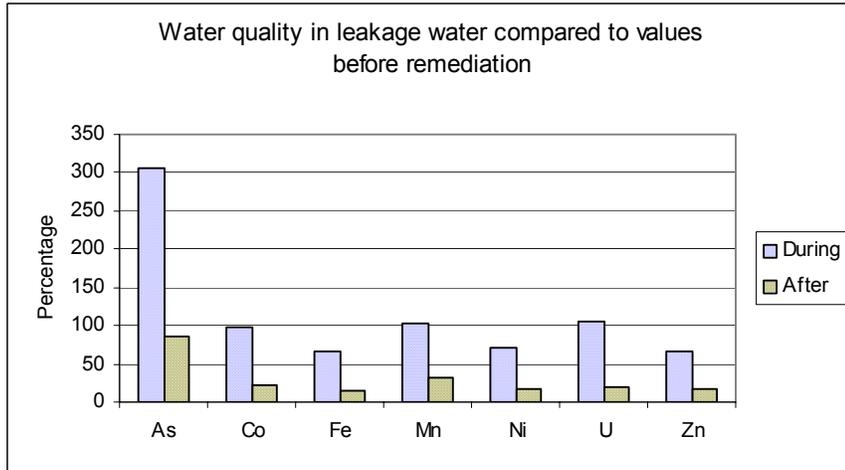
Figure 4 Water quality in leakage water during and after the remediation compared to the pre-remediation conditions

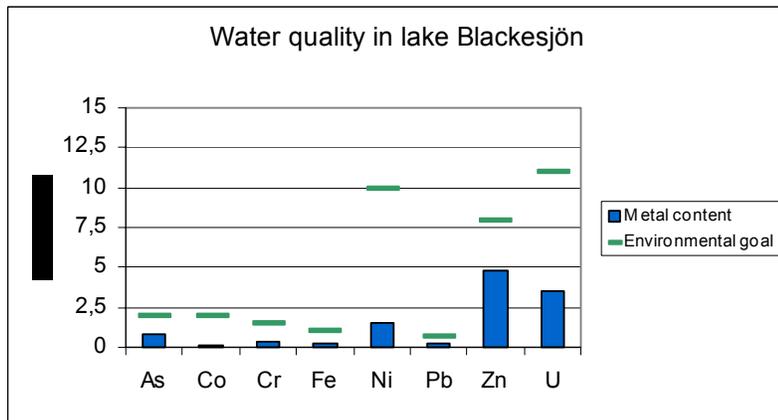
The environmental goals for the remediation were achieved in year 2000 for the lake Blackesjön, see figure 5.

Figure 5 The water quality in lake Blackesjön during year 2001 compared to the environmental goals
