2000 Billings Land Reclamation Symposium

EVALUATING THE EFFECTIVENESS OF STREAMBANK STABILIZATION TECHNIQUES FOR REDUCING BANK EROSION ON THE UPPER CLARK FORK RIVER, WESTERN MONTANA

GEOMORPHIC DEVELOPMENT OF A RECONSTRUCTED SUBALPINE STREAM CHANNEL

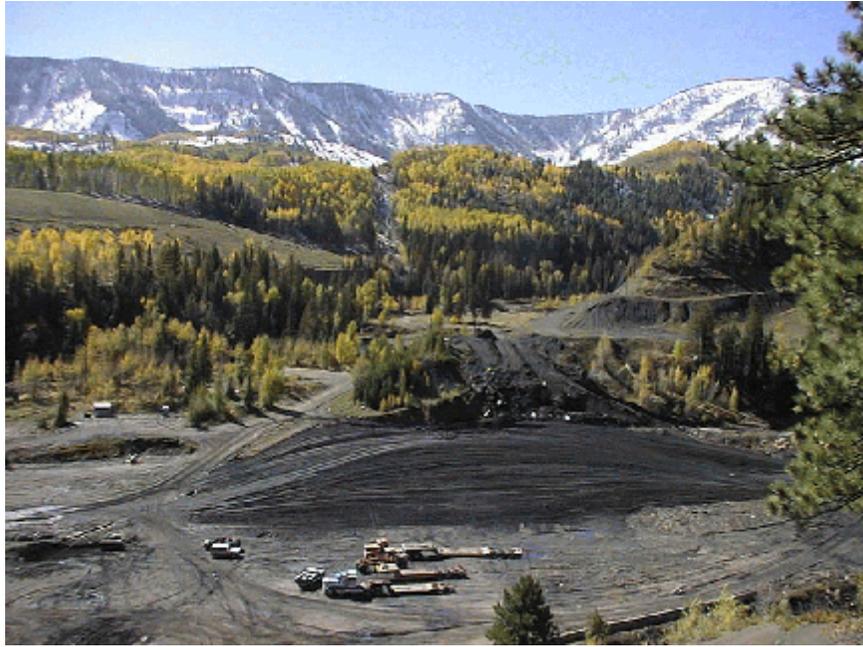
Figure 1 - The Dutch Creek Watershed and a portion of the project area.

The Dutch Creek watershed lies between about 8,000 feet and 11,000 feet AMSL and has a total drainage area of approximately 4.1 square miles. The Mancos Shale that underlies this watershed has been thermally metamorphosed, giving it greater resistance to erosion than the relatively soft unmetamorphosed Mancos Shale. Accordingly, the Dutch Creek watershed is relatively steep. Cliff-forming sandstone units within the Mancos Shale are found near the watershed divides and provide material for infrequently occurring debris flows (see Figure 1).

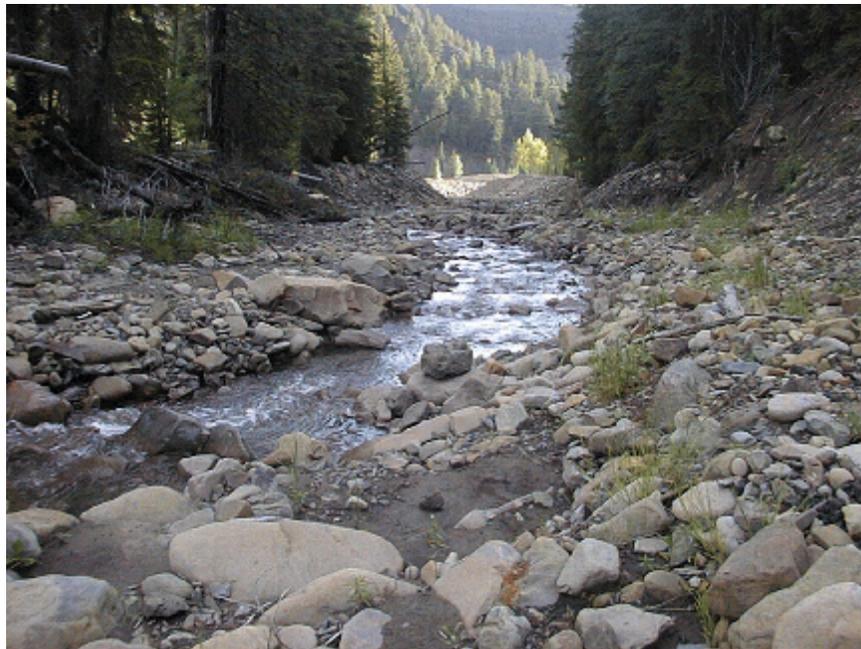
Figure 2 - View of native Dutch Creek showing channel in coarse debris flow material. The design for the 1250-foot reach of Dutch Creek through the project area was based only on Geomorphic design parameters (see Pranger et. al., 1996).

In late Fall of 1998, members of the State of Colorado, Division of Minerals and Geology (DMG) and the U.S. Office of Surface Mining Reclamation and Enforcement (OSM) supervised the construction of an unusual perennial stream channel at the former "Coal Basin mine." The stream - Dutch Creek - is unusual, because it is located in a scenic subalpine watershed (see Figure 1) and the primary channel-forming agents are infrequent cobble- and boulder-laden debris flows (see Figure 2).

The constructed channel had a fairly uniform 6.8 percent gradient, compared to 6.3 percent in the reference reach (See Table 1). The average gradient of the constructed channel was slightly higher than the reference reach due to spatial constraints in the project area. However, the channel stability was not decreased, because of the slightly coarser substrate material in the constructed channel (Figure 4). Also, the native channel width, depth, and sinuosity were closely approximated in the constructed channel. Images of the entire project area (Figure 5), the constructed channel (Figure 6) and the native channel (Figure 2) demonstrate that the channel had a natural appearance.

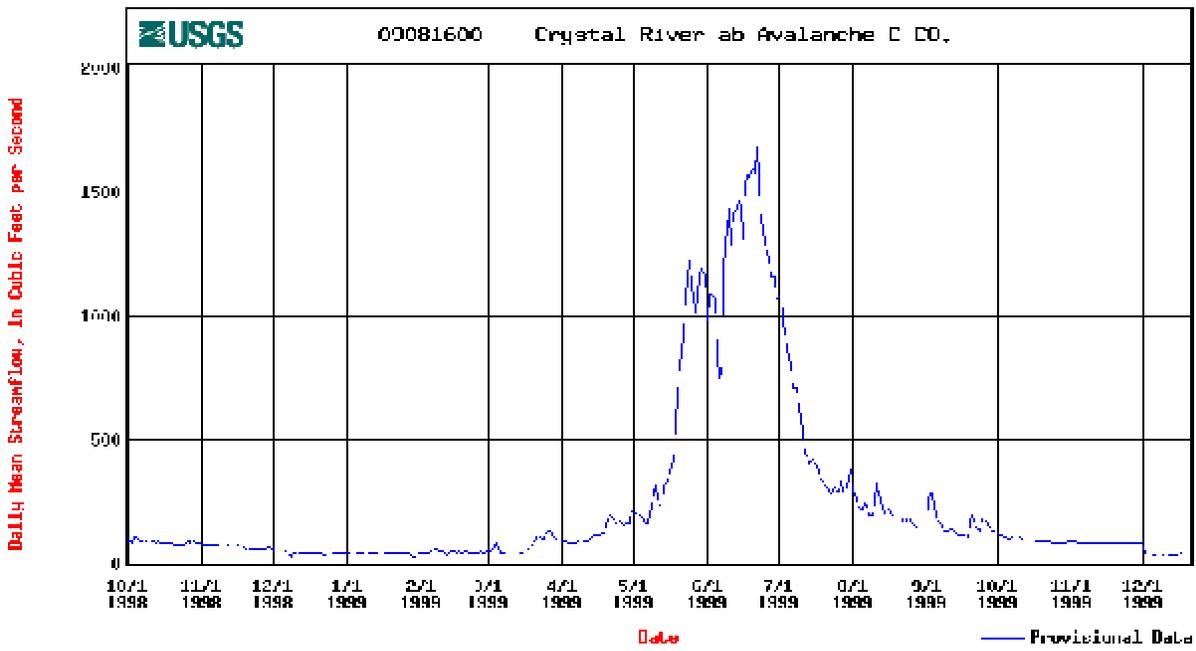
Figure 3 - USGS 1999 annual hydrograph for Crystal river seven miles downstream of the project area. Dutch Creek’s hydrograph has a similar shape and is indicative of snowmelt runoff.

Dutch Creek is a perennial stream that flows primarily in response to snowmelt runoff and secondarily to rainfall events and groundwater inflow (see Figure 3). Annual snowfall typically exceeds 200 inches at the project area. Rainfall in a high-elevation watershed such as this is typically far less intense than at lower elevations (Jarrett, 1990). Based on an extensive evaluation of USGS flow records, Jarrett (1987) found that Colorado streams above 2300 meters AMSL (7546 feet) produce a maximum unit discharge of 1.1 cubic meters per second per square kilometer. This maximum flow is 413 cfs at the mouth of Dutch Creek.

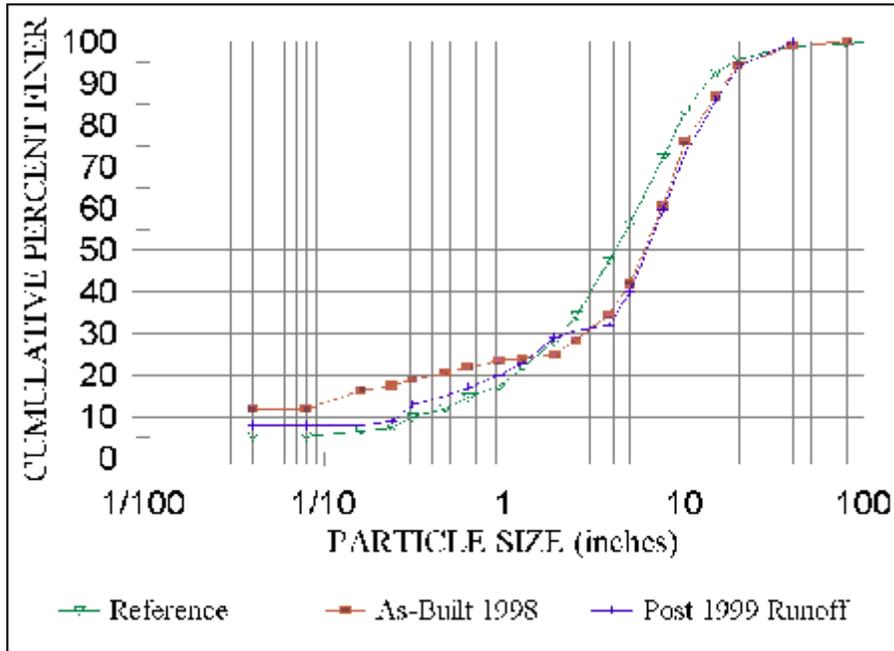
Figure 4 - Dutch Creek grain size distributions for the reference reach (Reference), the constructed reach immediately after construction (As-Built 1998), and the constructed reach after the 1999 runoff season (Post 1999 Runoff), based on Wolman pebble counts.

Wolman pebble counts were used to determine the substrate grain size distributions of the reference reach and the constructed channel (see Wolman, 1954 and Figure 4). The distributions are all relatively similar. The distributions all range from boulders to clay particles. The D_{50} for the native and reclaimed channels, respectively, was four and six inches. After the 1999 runoff season the distribution of material greater than about two inches in diameter in the constructed channel remained constant. However, the amount of material smaller than two inches was reduced. The channel transported the excess fine fraction out of the system. The coarser fraction remained virtually unchanged. The distribution in the constructed channel after the 1999 runoff season is a composite of the native and as-built distributions.

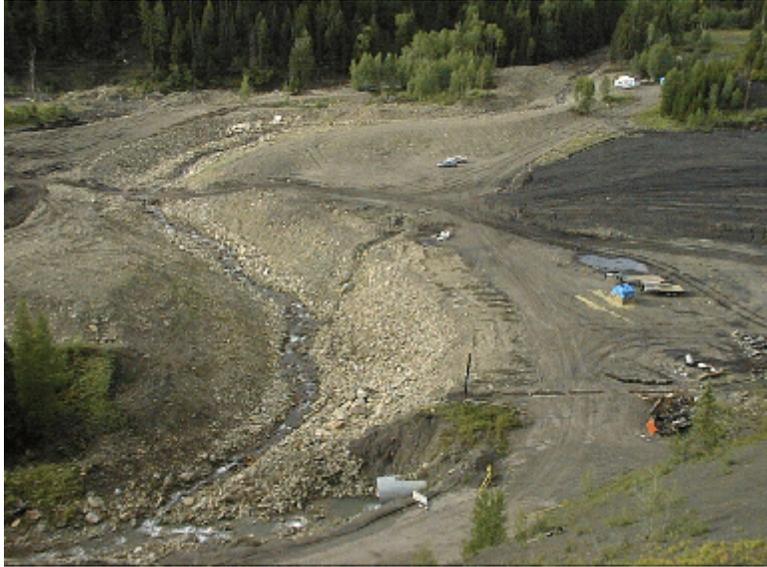
Figure 5 - Overall view of the reconstructed Dutch Creek channel.

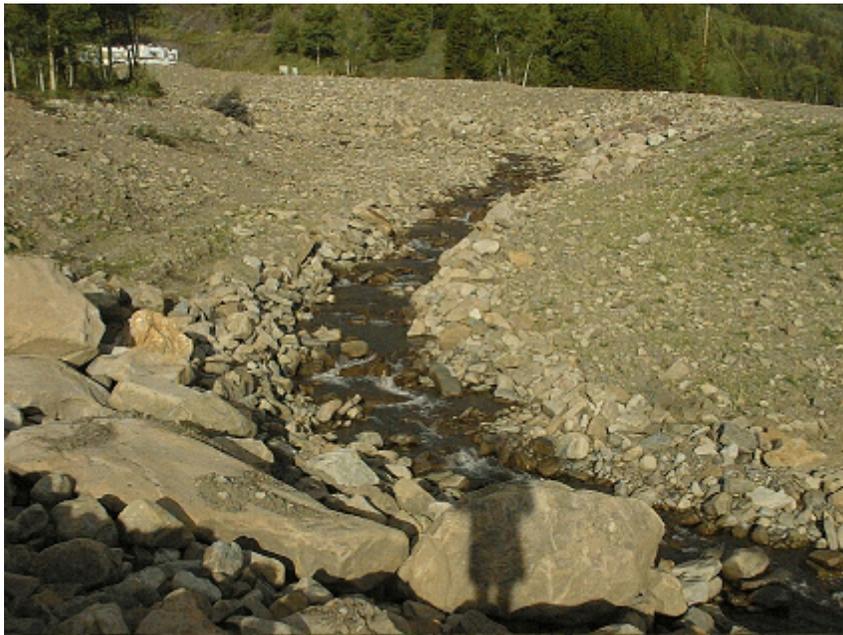
Figure 6 - Example reach of reconstructed Dutch Creek channel. Notice step pools.

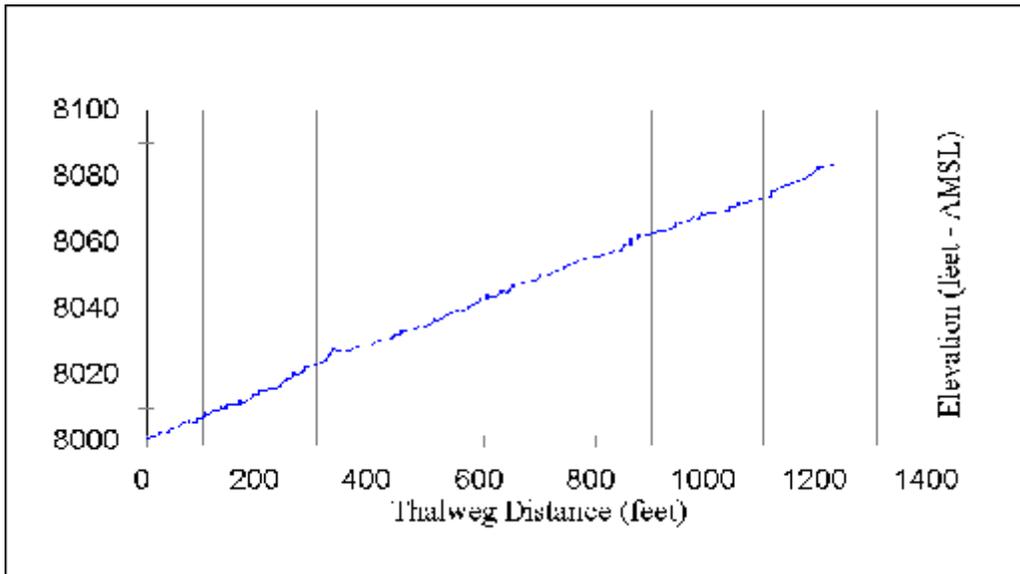
Figure 7 - Reconstructed Dutch Creek thalweg profile. Small undulations are step pools, except for the one at a distance of about 340 feet, which is a temporary road crossing.

The profile of the reconstructed channel thalweg after the 1999 runoff season indicated that the channel bed experienced only minor vertical adjustments (Figure 7). The minor vertical adjustments are step pools that developed from the redistribution of cobbles and boulders within the channel during high flow (Figures 6 and 7). The step pools in the constructed channel function and appear indistinguishably from the step pools in the native channel. The development of step pools resulted in a new thalweg gradient profile that varied from about -10 percent to +50 percent (Figure 8).

The highly variable thalweg gradient profile did not indicate a stability problem, because the native channel had a similarly variable thalweg gradient profile (see Pranger et. al, 1996) and there was no indication of channel incision (Figure 7). Also, the reconstructed channel did not measurably widen or migrate laterally during the 1999 runoff season. Stream channel instability is indicated when a stream is: 1) aggrading; 2) degrading; 3) changing bed material particle sizes; 4) changing the rate of lateral migration through accelerated bank erosion; and/or 5) changing morphological type through evolutionary sequences (Rosgen, 1995). This channel has not changed its stream type (a Rosgen type A3 channel), and has no visible signs of instability.

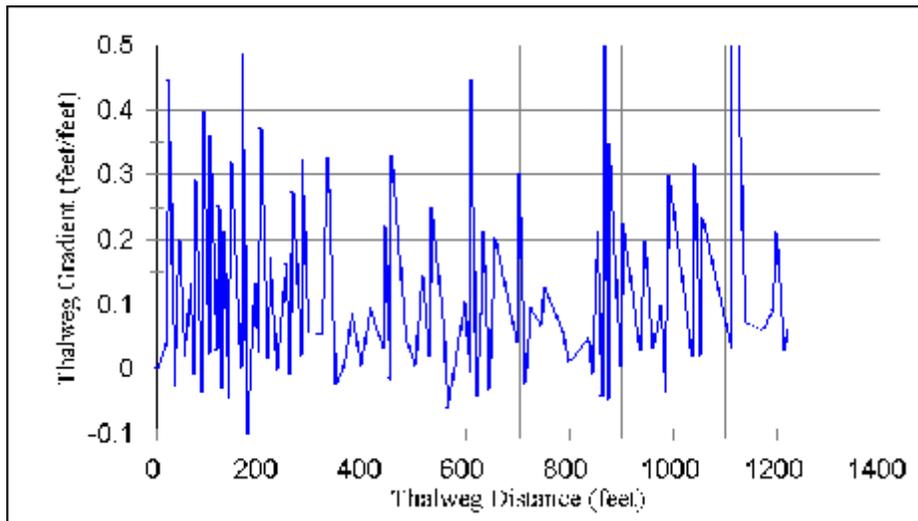
Figure 8 - Reconstructed Dutch Creek thalweg gradient profile after 1999 runoff season.
